Human Settlements and the Role of Natural Disasters: A Case Study of Landslide at Tepe Mehr Ali

Mahmood Heydarian¹, Majid Sarikhani², Alireza Sardari Zarchi³, Yaser Mrdani⁴, Mohsen Mardani⁵

Keywords: Landslides; Tepe Mehr Ali; Balangan River; Ancient Layer; Trench; Geo-Archeology.

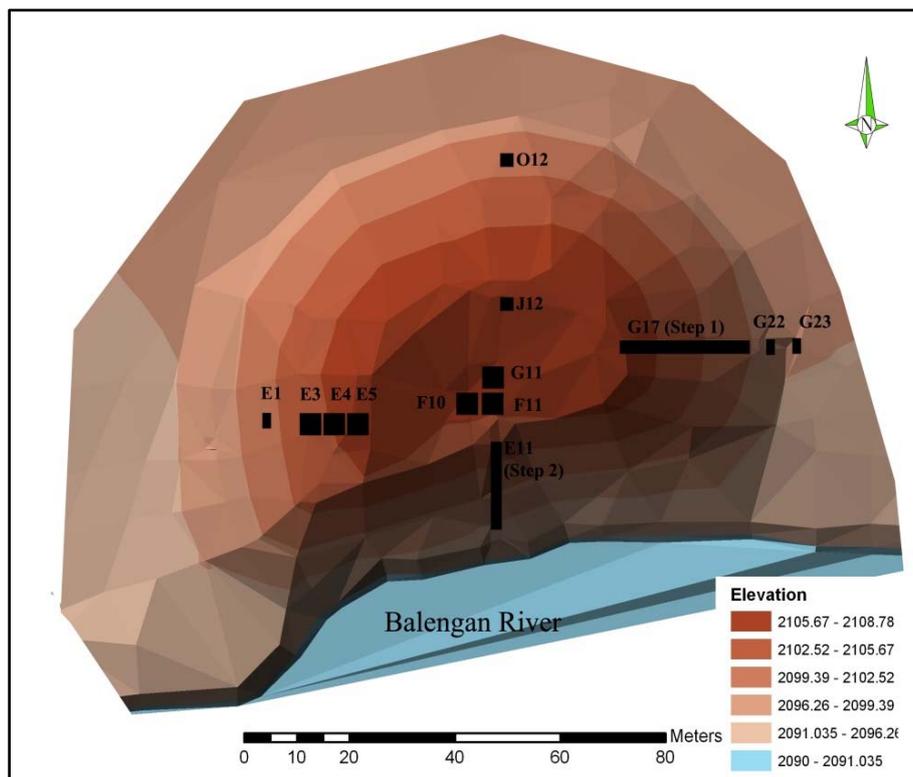
Fig. 2 Location of 11 Major Trenches at Different Spots of Tepe Mehr Ali

According to the results obtained from excavation of 11 surrounding at different spots of the mound (Fig. 2) and radio carbon experimentation of recovered coal pieces, it seems that after a consecutive establishment in the Shams Abad period - 5000 B.C. - until the Banesh period - 3400 B.C., this mound had constituent cultural layers. Data analysis indicated that it was settled during the late Neolithic- early Chalcolithic (Shams Abad) age. Again, in Bacon and Lapoi periods, there was a burst of population and therefore settlements. This mound was abandoned at the end of the late Banesh period. The reason why Tepe Mehr Ali was

Archaeological data collected from 11 trenches on this tepe was surveyed (Fig. 2). Accordingly, finding no trace of landslide, Trench J12 was chosen as the evidential sample for perception of

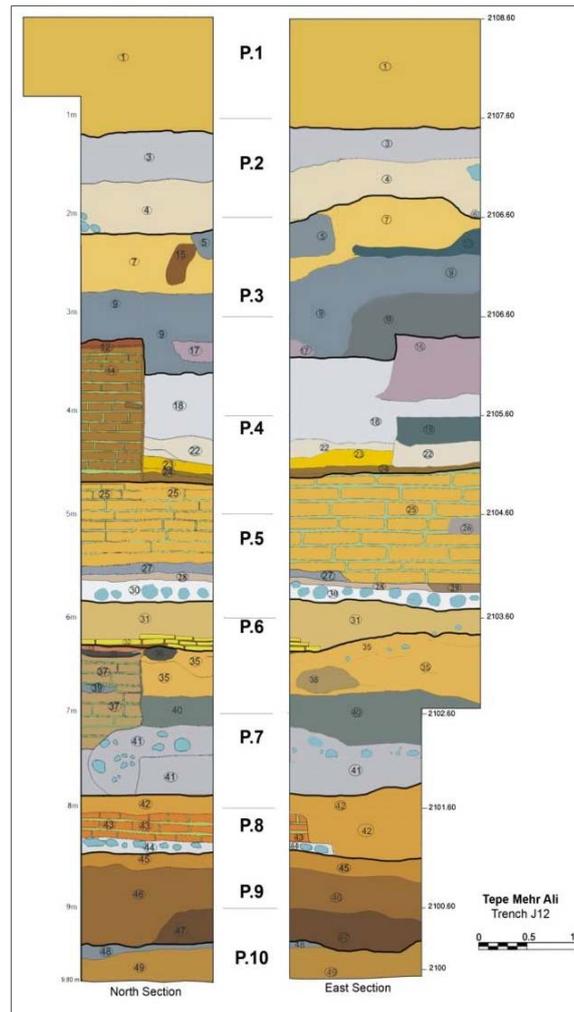
Fig. 3 Stratigraphical Section of Trench J 12.

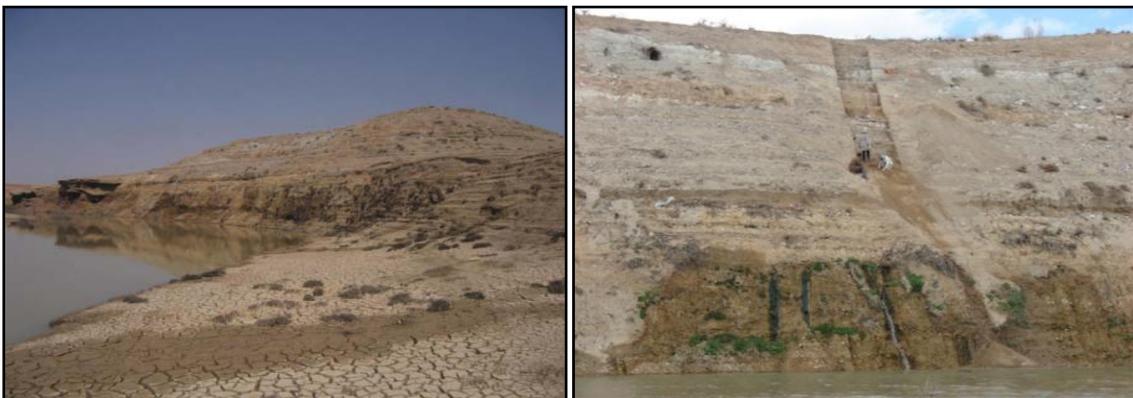
Fig .4 Right: High Level of Underground Waters and Their Flow Through the Mound, Left: Clay Mineral in Between Various Ancient Layers.

southern hillside to rupture because of the gravity and are still continuing, some other factors can also be referred to as triggers such as high levels and flow of underground waters through the mound, heavy snow weight on the hillside, permeation of snow melting waters and abundant amount of clay minerals in between the ancient layers. Among these factors, the water permeation in clay minerals caused them to act as lubricant and decrease soil-cutting resistance and play an important role in landslide occurrence. The most obvious archeological evidences of this phenomenon are the crooked layers and their falling in Trenches F10 and F11 showing the extensiveness of the landslide on the mound. From these trenches toward the

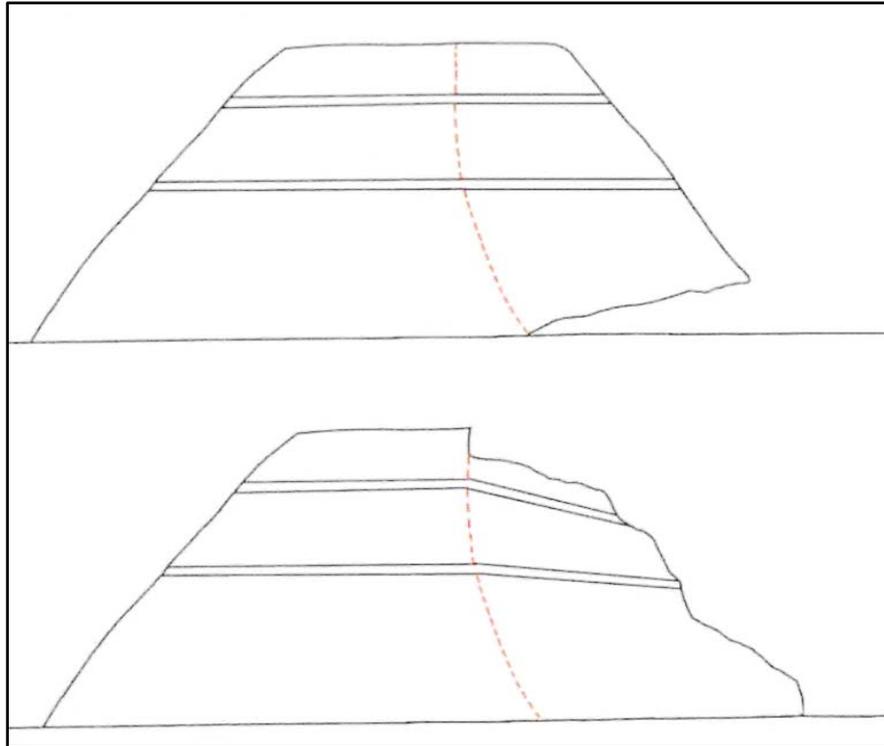
Fig. 5 Schematic Design of Landslides Occurrence Mechanism, Water Permeation on Southern Slopes of Tepe

in landslides occurrence (Fig.5). Permeation of raining and other water sources on the hillside increases pore pressure, decreases soil suction and increases soil weight and finally, decreases soil cutting resistance and causes the hillside to slide (Giannecchini, 2006). But other factors such as water permeation manner, soil features, dampness and raining history must be considered, too (Wieczorek, 1996).

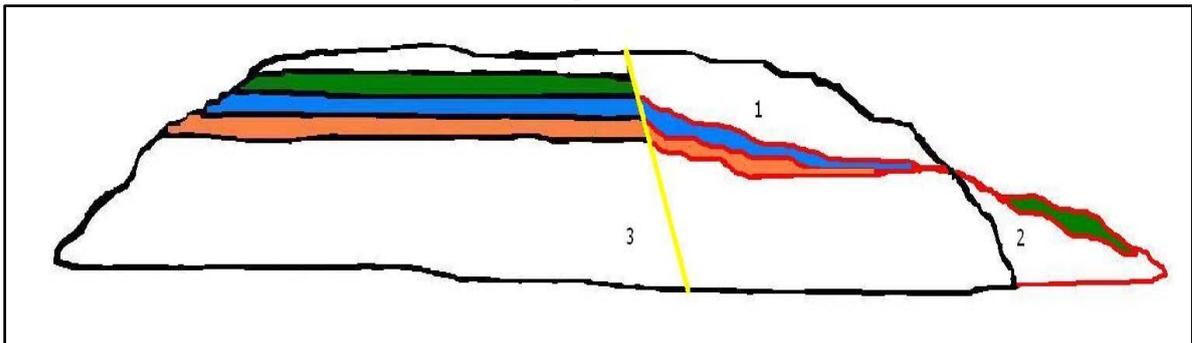
Fig. 6 Schematic Design of Landslides Occurrence Mechanism, 1: Empty Zone, 2: Accumulation of Displaced Material, 3: Boundary Level of Rupture.

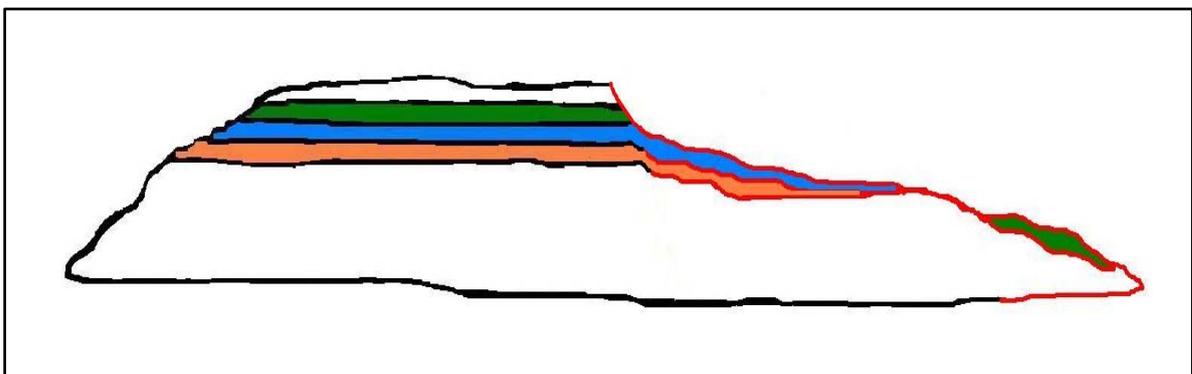
Fig. 7 Schematic Design of Landslides Occurrence Mechanism

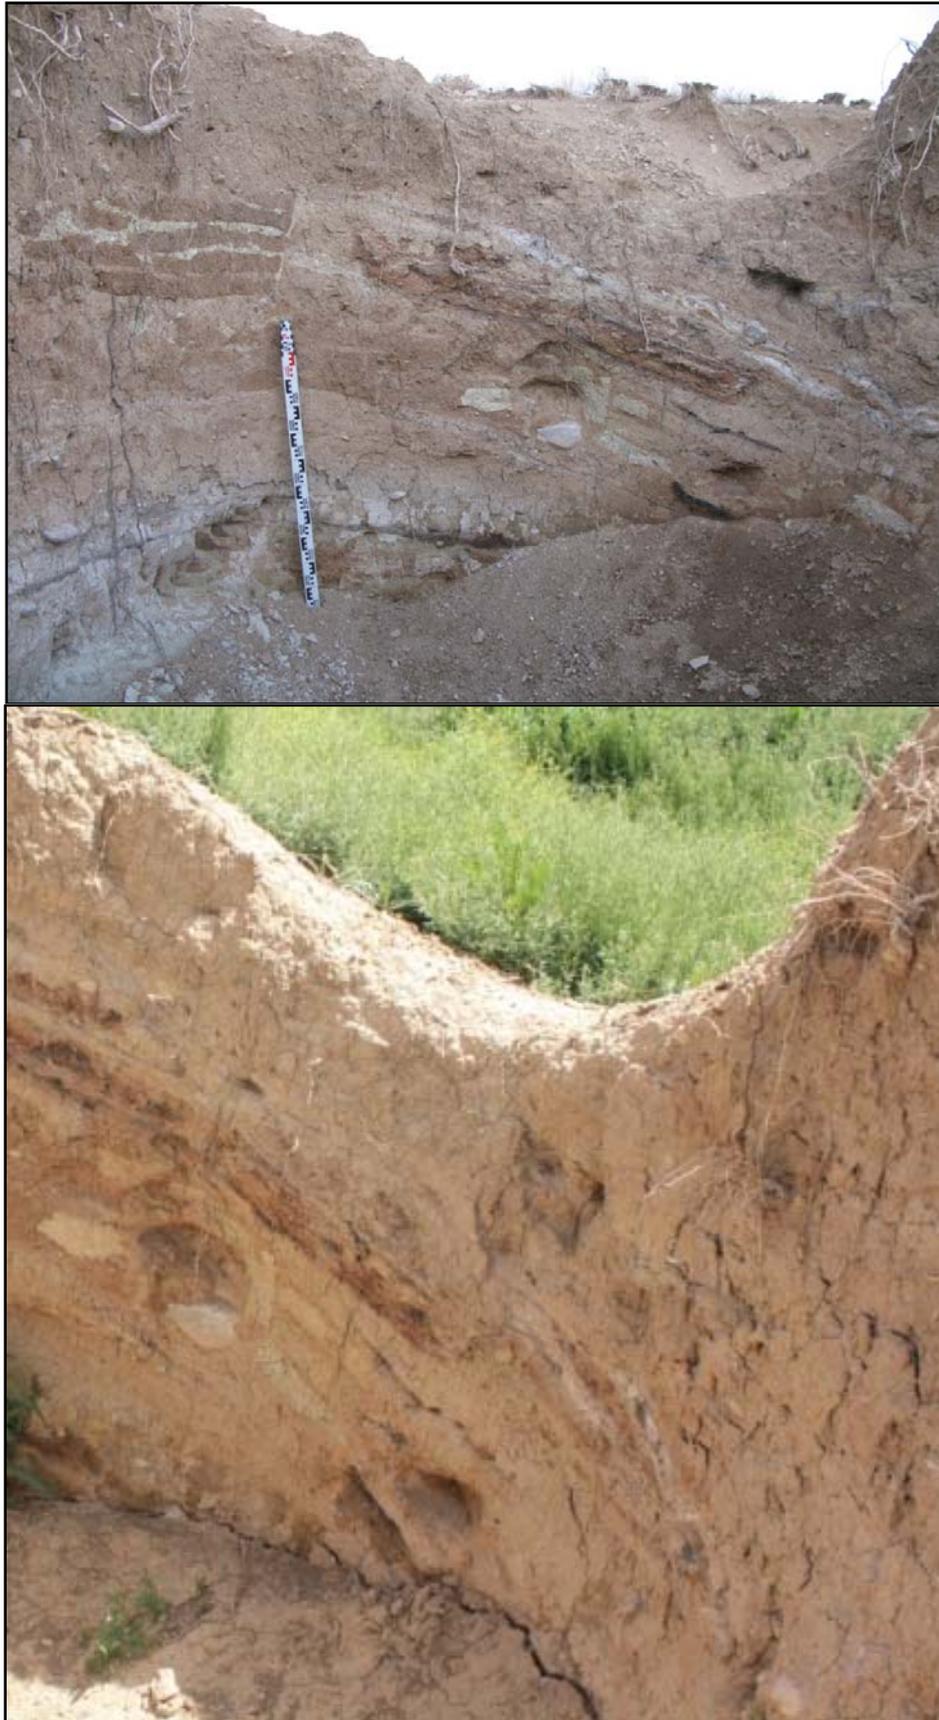
Fig. 8 Trench F 10, Top: Brick layers that are Crooked in an Abnormal Shape

The most prominent evidence of landslide occurrence belongs to the eastern cut of Trench F10 (Figs. 8 and 9). The pictures and plans of this trench show rows of brick layers that are crooked in an abnormal shape. These evidences are also obvious in Trench F11 (Fig. 10), which is the adjacent trench. Investigating the layers of the eastern and western walls of these trenches and comparing them with Trench J 12 (Fig. 3) as the control trench that was not affected by landslide clearly shows that the ancient layers are cut, crooked and disordered. The crookedness and cut of the walls toward the south are visible along with eastern and western walls of Trenches F10 and F11 and are visible from a depth of 1 meter to 5 meters in all layers. In deeper places, the layers are horizontal again (Sardarizarichi and Rezayi, 2007).

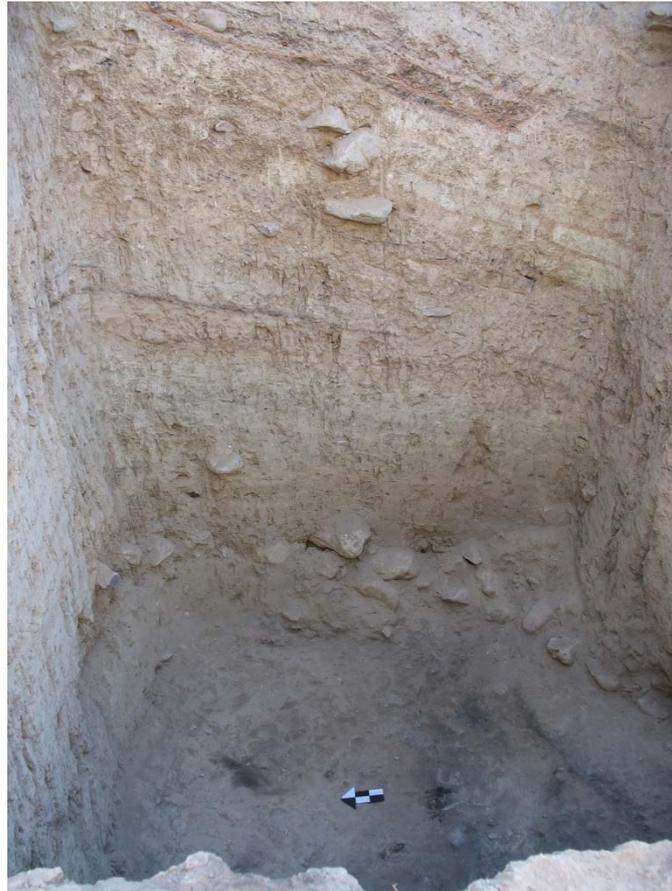
Fig. 9 Trench F11, View of Eastern Wall of Trench, Brick Layers that are Crooked Abnormally

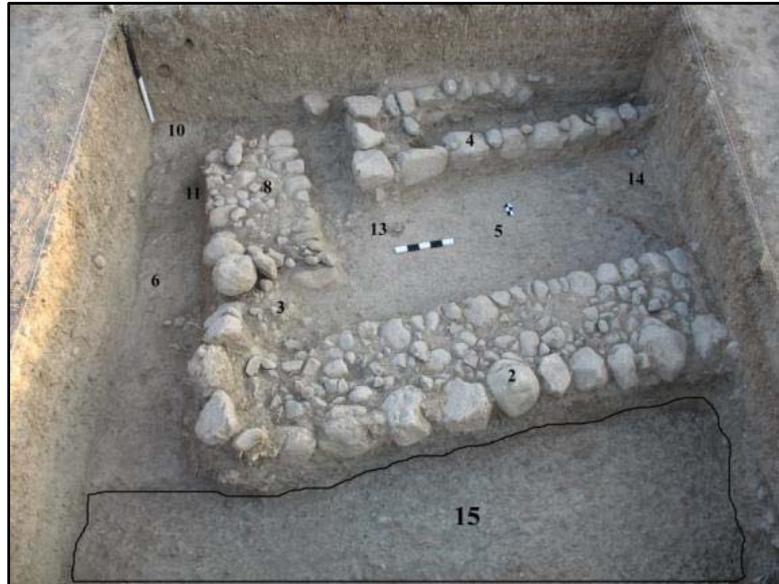
Fig. 10 Trench F 11: The Rocky Wall, Which was the First Archaeological Layer, Obtained from Excavations and Horizontally Settled on the Destroyed Walls of Lapoi Period

Investigating the cultural layers of Trench F11 indicates settlement of a rocky wall (Fig. 10) on the landslide ruins. This rocky wall, which was the first archaeological layer, obtained from excavations and horizontally settled on the destroyed walls of the Lapoi period, which belongs to the ancient Banesh period. Based on the settlement of this wall on the underlying ruins and its horizontal shape, it can be inferred that it was established after the landslide. Therefore, the estimated time for the landslide occurrence could be some time toward the end of the Lapoi period, which was before the start of the Banesh period.

north of the mound, there is no sign of landslide. Investigation of cultural layers obtained from Trench F11 shows the settlement of a rocky wall on the landslide ruins. This wall, which is found while excavating the first archeological layer, belongs to the ancient Banesh period and is settled horizontally on the ruins and destroyed walls of that period.

According to horizontal settlement of this wall on the ruins, it can be deduced that its structure belongs to the post-landslide era. Therefore, the landslide might have occurred toward

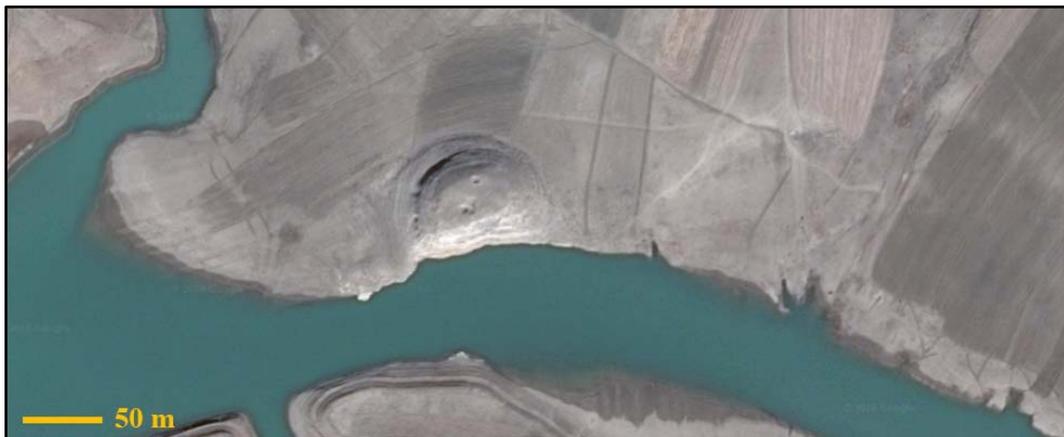
Fig. 11 Aerial Map of the Tepe in the Balangan River
